Modular titanium alloy neck adapter failures in hip replacement - failure mode analysis and influence of implant material

Abstract

Cite this article as: Grupp et al.: Modular titanium alloy neck adapter failures in hip replacement - failure mode analysis and influence of implant material. *BMC Musculoskeletal Disorders* 2010 **11**:3.

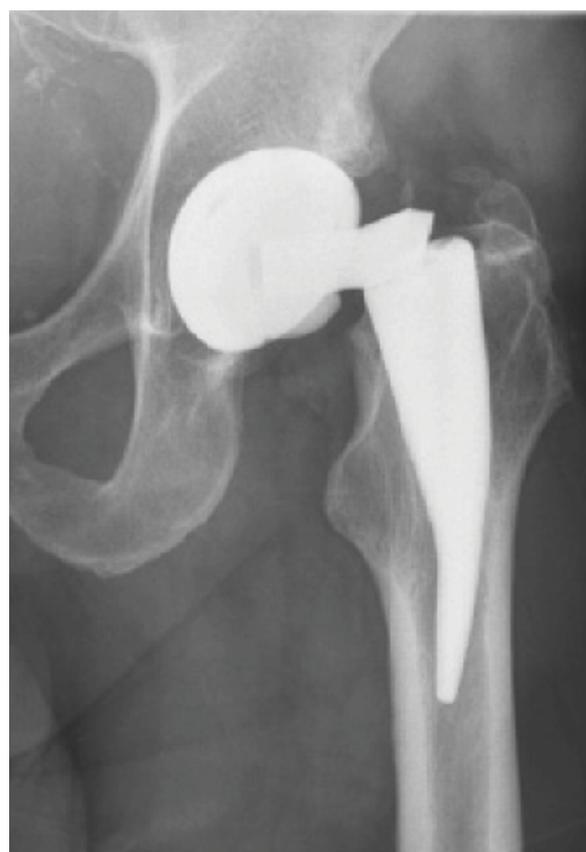
The failed neck adapters were implanted between August 2004 and November 2006. After the third incident, the titanium neck adapters were replaced by adapters out of cobalt-chromium [8]. A typical x-ray of a failed titanium neck adapter is shown in Figure 1.

Figure 1 X-ray of a hip with a failed neck.

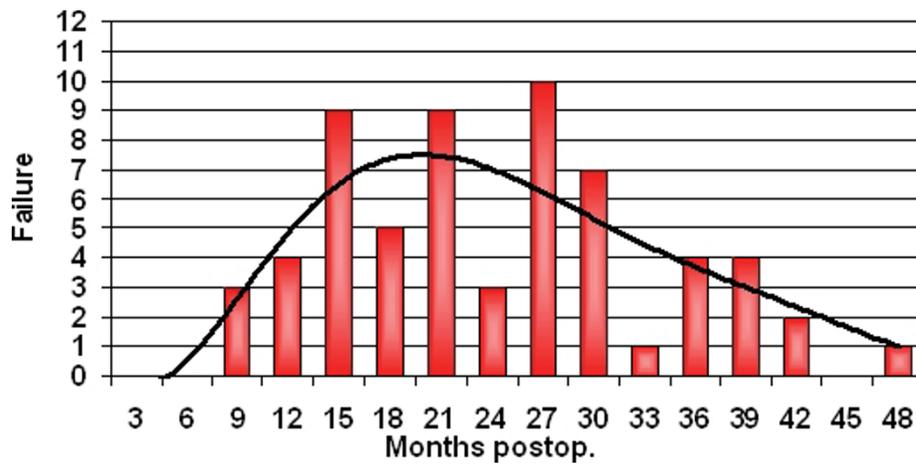
Figure 2 Occurrence of clinical neck failures in a postoperative time period in months.

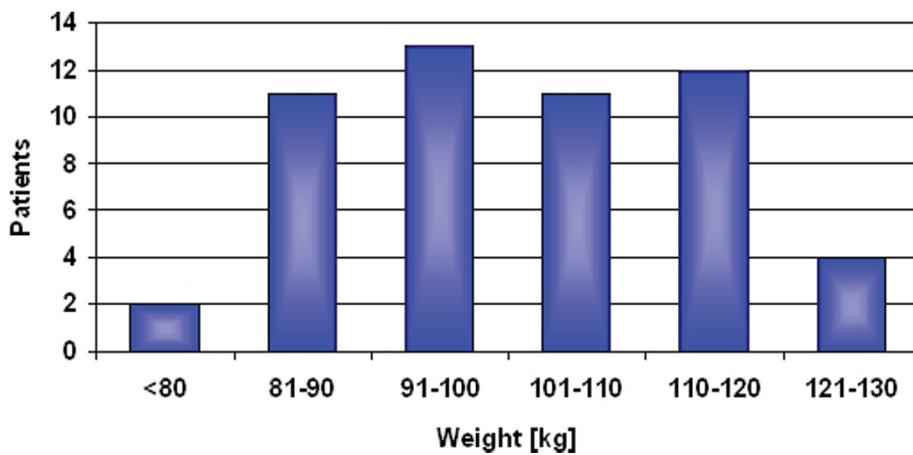
The failure of the neck did not cause further damage on the acetabulum side. Subsequently, there was no need to revise the cups in all of these cases. Modular cup inserts were replaced in some cases due to visible signs of damage originated by the neck failure or for reasons of precaution. About 5000 hip joints have been implanted with the titanium stem and titanium neck adapter material combination. Until the end of 2008 1.4% ($n = 68$) of the titanium alloy neck adapters failed after an average time in vivo of 24 months (Figure 2). All, but one, patients were male and most patients (59%) had a weight above 100 kg and an average body mass index (BMI) of 31.6 (24 to 42) (Figure 3).

Figure 3 Correlation weight of patients and failures.

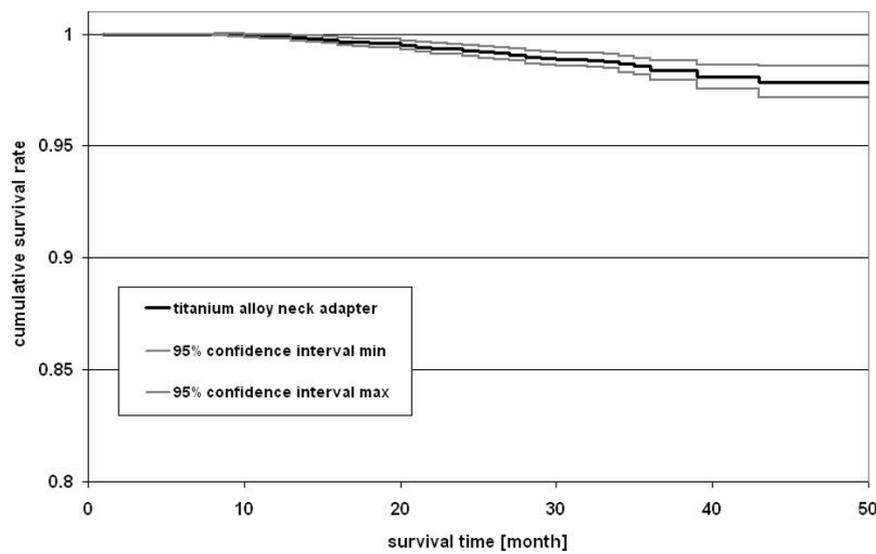
with revision due to failed neck adapter as an endpoint (confidence interval $\pm 95\%$). A cumulative survival rate of 98.6% was calculated with fractured neck adapter as the causative factor of failure (Figure 4).

Figure 4 Kaplan-Meier survival analysis for failed neck adapter as reason of revision (\pm 95% confidence interval).

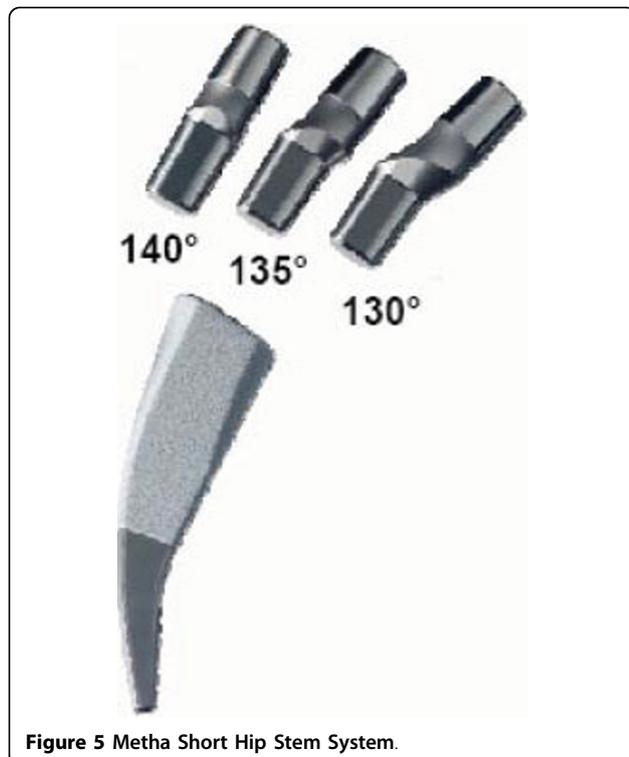
The modular neck adapters and stems used in our study were in all cases the Metha Short Hip Stem Prosthesis (Aesculap AG, Tuttlingen, Germany). Adapters and stems were made of titanium alloy. With its circumferential pure titanium porous coating and additive thin layer of dicalcium phosphate dehydrate (Plasmapore® μCaP , Aesculap, Tuttlingen, Germany), the stem is designed for cementless anchorage (Figure 5). The modular neck adapters were used in three different CCD-angles (130°, 135° and 140°) in combination with neutral, anteverted and retroverted ($\pm 7.5^\circ$) versions to adjust the CCD-angle intraoperatively [4].

Figure 5 Metha Short Hip Stem System.

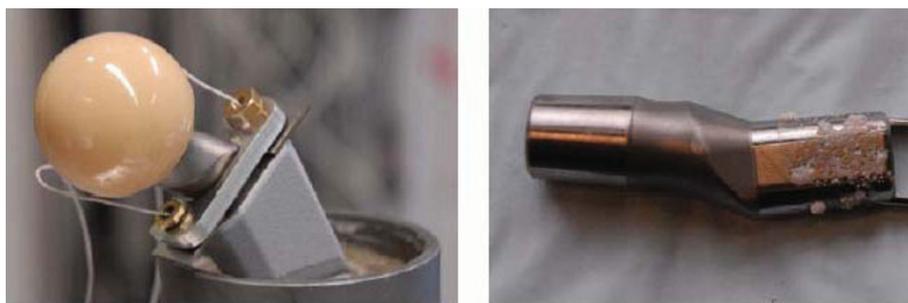
Figure 6 Test setup for measurement of micromotions in the modular cone connection (left) and particle-contaminated joining area (right) [18,19].

specimens with neck adapters out of titanium alloy and cobalt-chromium alloy were examined. As it appears that intraoperative contamination of the cone connection with bone particles has an considerable impact on the magnitude of fretting in the interface due to increased micromotions, a specific test setup was developed at the Biomechanics Section of the Hamburg University of Technology (Prof. Michael M. Morlock) and each device being tested with a clean and with a particle contaminated joining area (small porcine bone grafts approximately 1 mm in diameter) [18,19]. To determine the relative motion between neck adapter and stem a contactless measurement system (Micro-Epsilon Type U05(78) Messtechnik Ortenburg, Germany) was used. Two sensors with a range of 500 μm and a sensitivity of 0.025 μm were fixed on an aluminium plate and mounted on the neck adapter. Two steel plates fixed on the resection plane of the stem served as targets for the sensors (Figure 6).

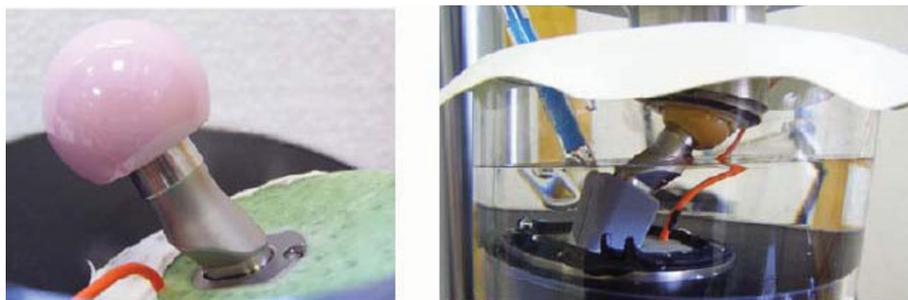
To evaluate the coaction of the stem/neck modularity with the hip stem, the modular stems were tilted both in the frontal plane ($\alpha = 10^\circ$) and in the sagittal plane ($\beta = 9^\circ$). Based on CT scans on several human femurs and the specific stem design the level of embedding was set to 45 mm below the centre of the head to simulate a deficiency of proximal support due to bone loss in the neck and trochanter region (Figure 7).

Figure 7 Test setup for neck test (left) and stem test (right) with reference electrode to measure corrosion potential.

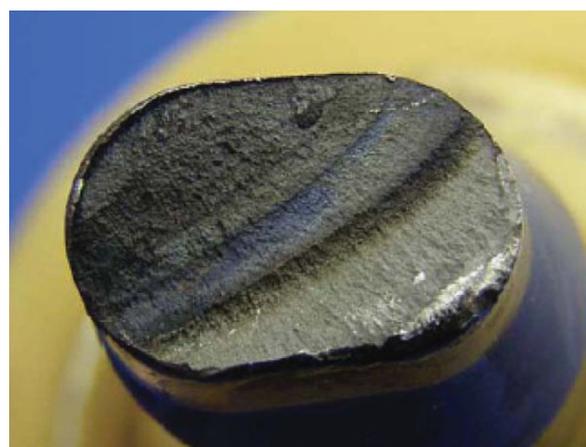
All retrieved modular adapters showed similar breakage cross-sections. The fatigue fracture starts in the anterolateral area at the upper part of the conical connection, the area subjected to maximum biomechanical stress. The fatigue fracture is followed by the residual forced fracture (Figure 8).

Figure 8 Fatigue fracture surface of a clinically failed titanium neck adapter.

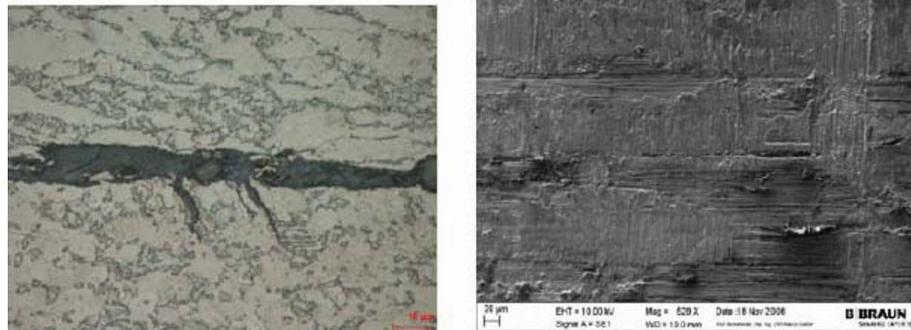
Metallographic analyses showed that microcracks developed on the surface of the cone in the clamping range (Figure 9). It appears that these microcracks induced the fatigue crack which finally led to the implant failure. Microcracks were analyzed using a scanning electron microscope. Figure 9 shows a potential micro crack in an area where fretting marks can be seen on the surface of the cone.

Figure 9 Metallographic analyses revealed microcracks on the cone surface (left) and a potential microcrack in a fretting area (right).

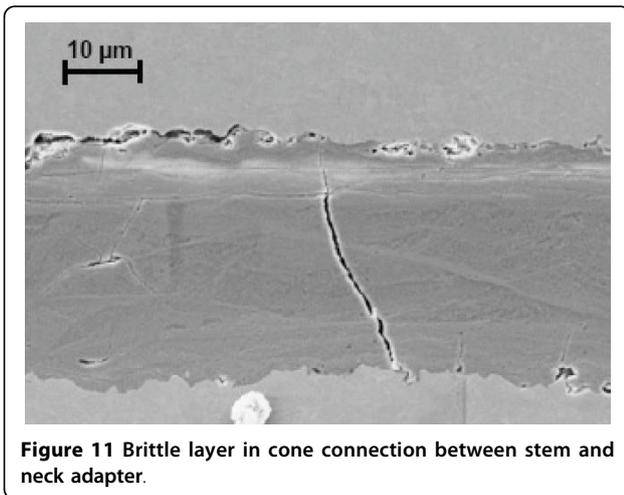
The findings of the corrosive alteration apart of fretting have not been corroborated by biomechanical tests so far [8,14]. Metallographic cross sections of the cone show a 20 µm up to 30 µm thick layer developing in the modular joining area of most of the revised implants (Figure 11), a layer composed of different abrasive and corrosive substances including a high amount of titanium dioxide. The layer was formed due to abrasion of the passive oxide layer protecting the titanium alloy against corrosion. Continued abrasion and repeated repassivation of the titanium alloy surface produced the oxide layer's characteristic thickness.

Figure 11 Brittle layer in cone connection between stem and neck adapter.

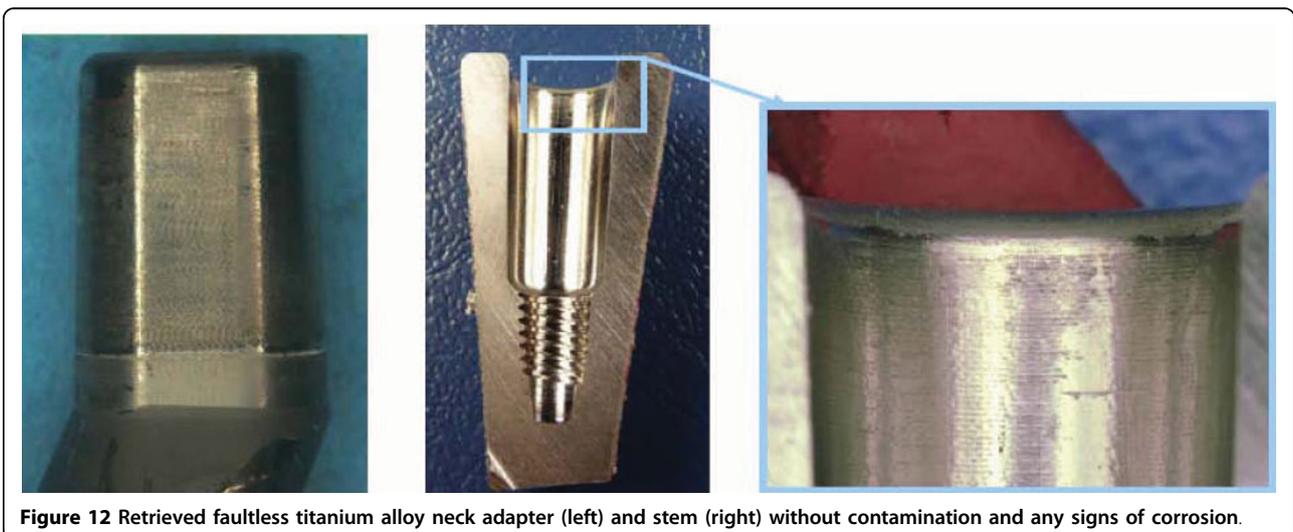
In one patient weighing 100 kg, a revision had to be carried out after 26 months to improve the offset due to cup loosening, thus providing the possibility to examine a faultless titanium adapter. (Figure 12).

microscope. No calcium or phosphor could be detected. There was no indication of a contamination of the cone connection by bone particles. Besides mild abrasion on the surface, no signs of fretting corrosion could be found.

Figure 12 Retrieved faultless titanium alloy neck adapter (left) and stem (right) without contamination and any signs of corrosion.

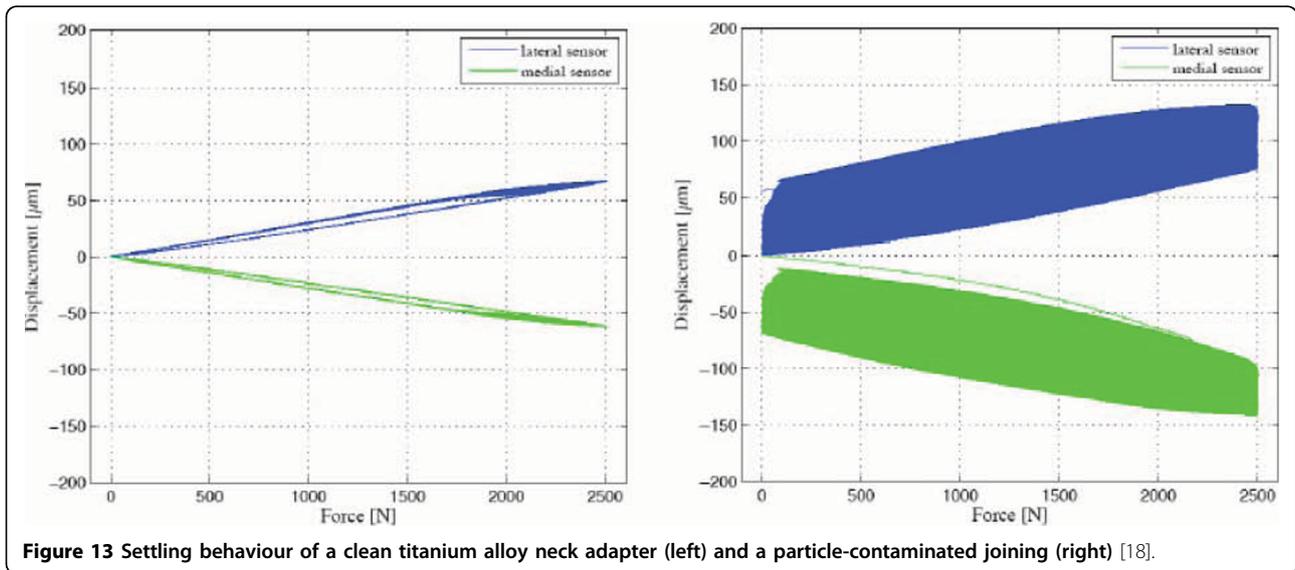
The major part of the observed displacement was caused by elastic deformation of the neck adapter. The micromotions of the titanium neck adapter were in a clean condition $6 \pm 4 \mu\text{m}$ (medial) and $6 \pm 2 \mu\text{m}$ (lateral) and with particle contamination $18 \pm 3 \mu\text{m}$ (medial) and $15 \pm 4 \mu\text{m}$ (lateral). In each contaminated joining area, the displacement and the micromotions were larger than in a clean condition. The fully uncontaminated components showed a distinct and definitive settling within the first 20 cycles. In case of a contaminated joining area the settling process of the neck adapter did not come to an end and lasted over the entire test duration (2000 cycles) (Figure 13).

Figure 13 Settling behaviour of a clean titanium alloy neck adapter (left) and a particle-contaminated joining (right) [18].

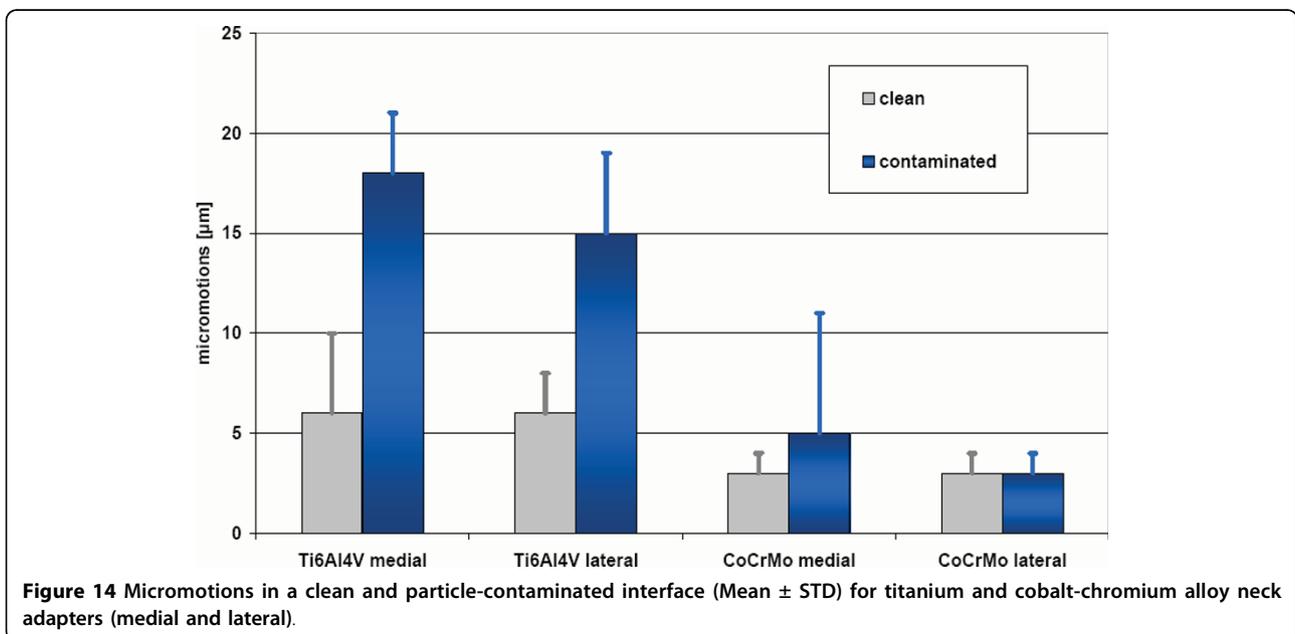
The titanium alloy neck adapter showed a significant increase of micromotions in the interface of the particle-contaminated joining ($p < 0.01$) in comparison to clean conditions (Figure 14). The micromotions of the

neck adapter out of cobalt-chromium were in a clean condition $3 \pm 1 \mu\text{m}$ (medial) and $3 \pm 1 \mu\text{m}$ (lateral) and with particle contamination $5 \pm 6 \mu\text{m}$ (medial) and $3 \pm 2 \mu\text{m}$ (lateral).

Figure 14 Micromotions in a clean and particle-contaminated interface (Mean ± STD) for titanium and cobalt-chromium alloy neck adapters (medial and lateral).

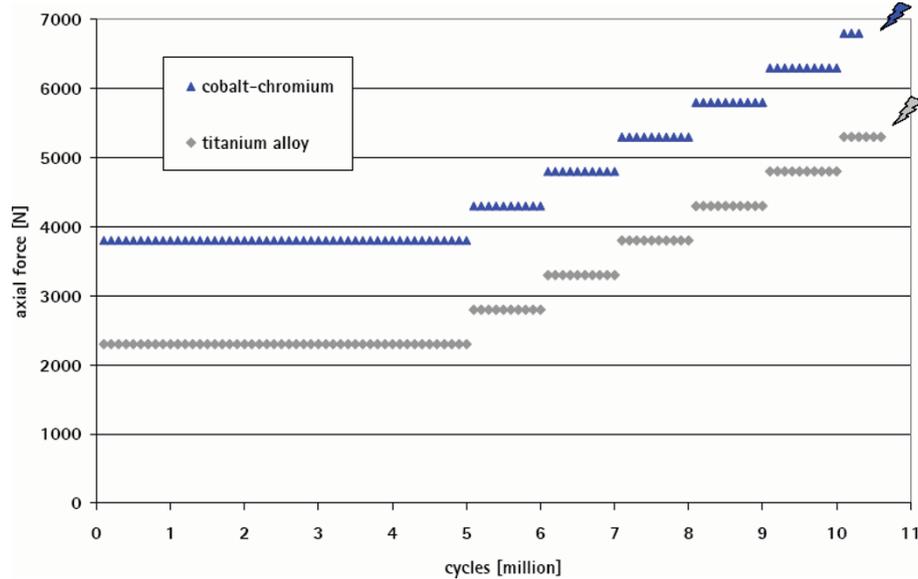
direct comparison, the cobalt-chromium neck adapters did not fail in the Locati test until the stem fractured at 6800 N load after 0.3 million cycles (Figure 15). Furthermore, the cobalt-chromium neck components did not fracture at 5300 N during 10 million cycles.

Figure 15 Endurance behaviour of the modular stem and different failure mechanisms for neck components made of titanium (failure of the neck adapter) and of cobalt-chromium alloy (fractured stem at a level below the embedding).

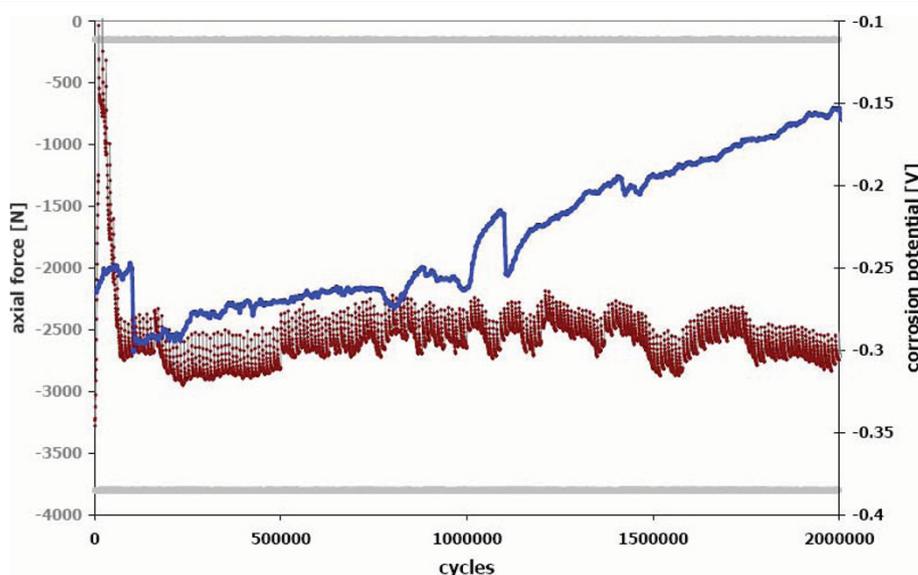
mechanical disturbance which triggers repassivation processes in high frequency (Figure 16).

Figure 16 Free redox potential with frequent repassivation processes in the particle-contaminated modular neck interface (red curve) compared with a clean joining (blue curve).
