TECHNICAL ADVANCE

# Method for the location of primary wear scars from retrieved metal on metal hip replacements

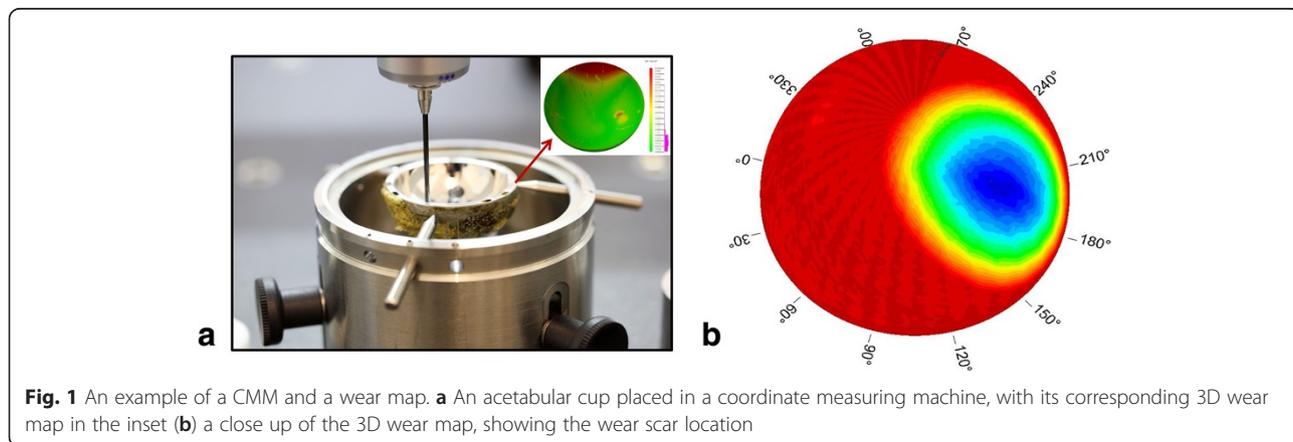
**Fig. 1** An example of a CMM and a wear map. **a** An acetabular cup placed in a coordinate measuring machine, with its corresponding 3D wear map in the inset **(b)** a close up of the 3D wear map, showing the wear scar location

To determine the location of the wear scar, each of the bearing surfaces of the cup were measured using a Zeiss Prismo (Carl Zeiss Ltd, Rugby, UK) coordinate measuring machine (CMM). Previously published protocols [8] were used to take up to 300 000 unique data points on the surface by translating a 2mm ruby stylus along 400 polar scan lines. An iterative least square fitting method was used to analyse the raw data, allowing a 3D wear map of the cup under study to be generated (Fig. 1). An unworn cup should have had a uniform depth throughout the cup, and any areas of increased depth reflected locations of wear patches. The  $WS_1$  could be visualised according to their location according to concentric zone (Fig. 2). The location of  $WS_1$  was also noted in terms of degrees clockwise from the acetabular features (Fig. 3) which were used as markers for rotational identification.

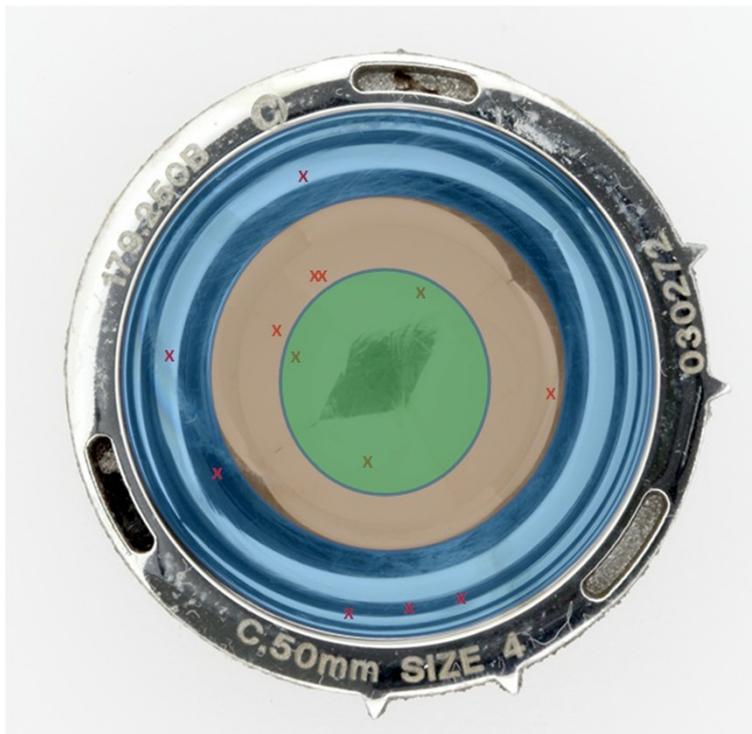
**Fig. 2** Distribution of primary wear scars. The schematic distribution of the 13 wear scars superimposed on a picture of a metal acetabular cup and arranged according to whether they are found in the outer (blue), middle (orange) or inner (green) zones

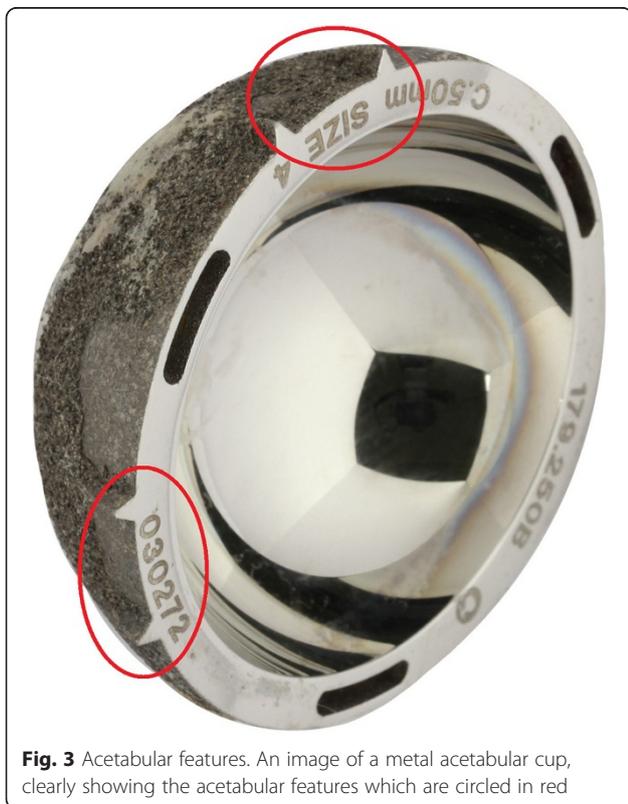
**Fig. 3** Acetabular features. An image of a metal acetabular cup, clearly showing the acetabular features which are circled in red

Acetabular fins are intended add to the component's stability [10], but in this case they could be used as a

reference point in this co-registration process. Due to the spherical nature of the acetabular cup, without these acetabular fins the orientation of the explanted cup *in vivo* would not have been possible.

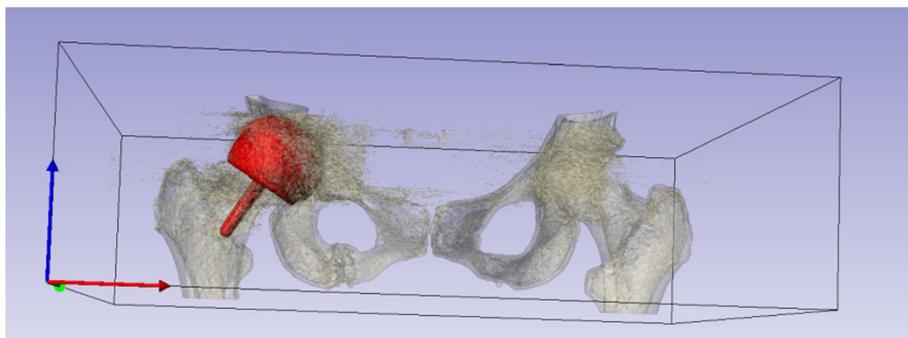
**Fig. 4** 3D CT methodology. An example of the co-registration process within the software used, showing the *in vivo* position of the implant within the pelvis

A low dose 3DCT protocol was followed [9], generating an image of the pelvis. The *in vivo* location of  $WS_1$  could be co-registered on this image as the location of the  $WS_1$  was known in relation to the acetabular cup rim and also in relation to the acetabular features. First, the acetabular features were located on the 3D CT image. Next, the angle in degrees between these fins and the  $WS_1$  was measured using the appropriate measuring tools. Finally, the vertical distance of the  $WS_1$  from the acetabular cup rim was measured. This gave us the epicentre of the  $WS_1$  and hence, the location of the  $WS_1$  of an explanted acetabular cup could be co-registered with its *in vivo* location (Fig. 4).

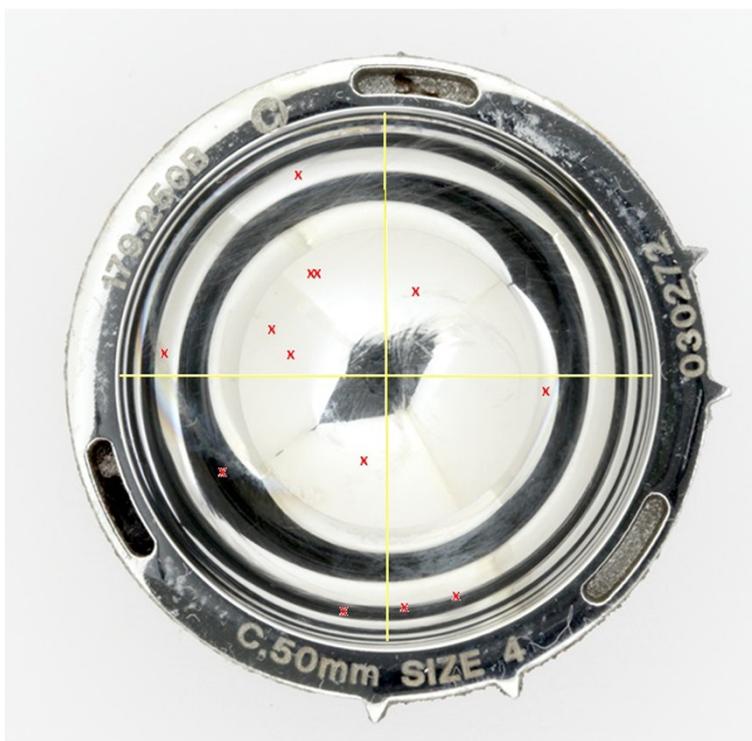
**Fig 5** Location of primary wear scars. An image of a metal cup on which each of the 13 wear scars is superimposed, according to which quadrant the wear scar was positioned

Using the method which was discussed the WS<sub>1</sub> was identified for all 13 components. The out-of-roundness machine was able to take circular measurements at 0.1° intervals around the acetabular cup rim and also in 0.5mm increments down from the acetabular cup rim. The location of the acetabular features was also noted successfully in all cases, allowing the co-registration of the *in vivo* location of the WS<sub>1</sub> to be visualised. A diagram was then produced showing a 3D representation the location of each of the thirteen WS<sub>1</sub> on a single acetabular cup. This allowed us to appreciate the range of their locations, with reference to the anterior pelvic plane, according to quadrants (Fig. 5).

The distribution of the location of the *in vivo* WS<sub>1</sub> can be reported as follows: six were in the upper outer quadrant; three were in the lower outer quadrant; one was in the upper inner quadrant; and three were in the lower inner quadrant. These results clearly show that the location of the *in vivo* WS<sub>1</sub> can be very variable, which does not fit with the current theory of edge loading [6, 7]. Further work can be done to correlate a range of factors with the location of WS<sub>1</sub>, and as such, the method devised here may be of huge importance. We did not
